# Sommerville Owners Association

## Bathymetry and Sediment Report May, 2023

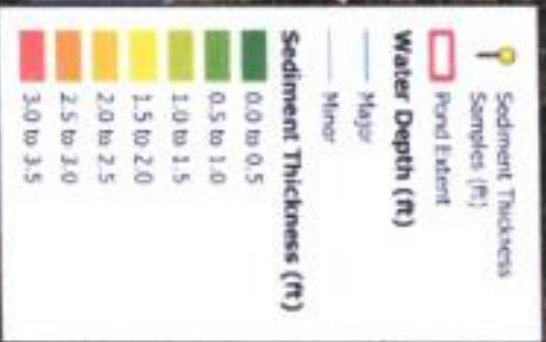
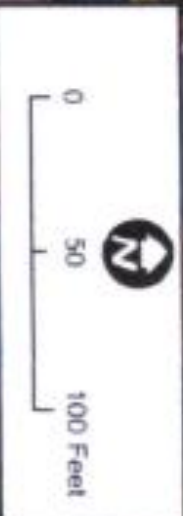
The contour map for the waterbody shows the configuration and current depth contours of the pond. The 3-dimensional depth representation provides shaded gradations that are helpful for visualizing the contours. The darker the blue color the deeper the water is in that area of the waterbody. The sediment map shows the locations and magnitude of unconsolidated sediment depth measurements. The unconsolidated sediment layer consists of soil particles and organic materials that have accumulated on the bottom of the pond, which remain penetrable by a manual depth sampling instrument.

We collected data points to calculate the size and volume of the pond. The pond measures an area of 2.1 acres, has a maximum depth of 5.9 feet, and has an average depth of 3.1 feet. The current storage volume of the pond is about 6.7 acre-feet, or 2,195,235 gallons. The manual sediment probe measurements taken throughout the pond gave an estimated sediment volume of 4,501.6 cubic yards with an average thickness of 1.3 feet. Most of the pond has moderate accumulation with the thickest amount of sediment measured at 3.0 feet.

**Pond Information:**  
Area: 2.1 acres  
Max Depth: -5.9 ft  
Mean Depth: -3.1 ft  
Volume: 2,195,215 gallons / 6.7 acre-ft

**Mapping Information:**  
Data Collection Performed: 10/6/2023  
GPS: Mapping Grade (sub-foot accuracy)  
Points Collected: 6,050  
Water Level: Adjusted to Full Pool

The pond is in moderate condition from a bathymetric standpoint. The pond still has just over 70% of its volume capacity, and appears to be operating normally. Continued monitoring of the sediment and water volume should be done periodically to track the succession of the pond, as well as normal stormwater maintenance practices such as water quality monitoring, structural inspections, and nutrient remediation.
